# **A Brief Report on Pen y Bryn and Aber, Gwynedd**

**by Paul Martin Remfry**

2012

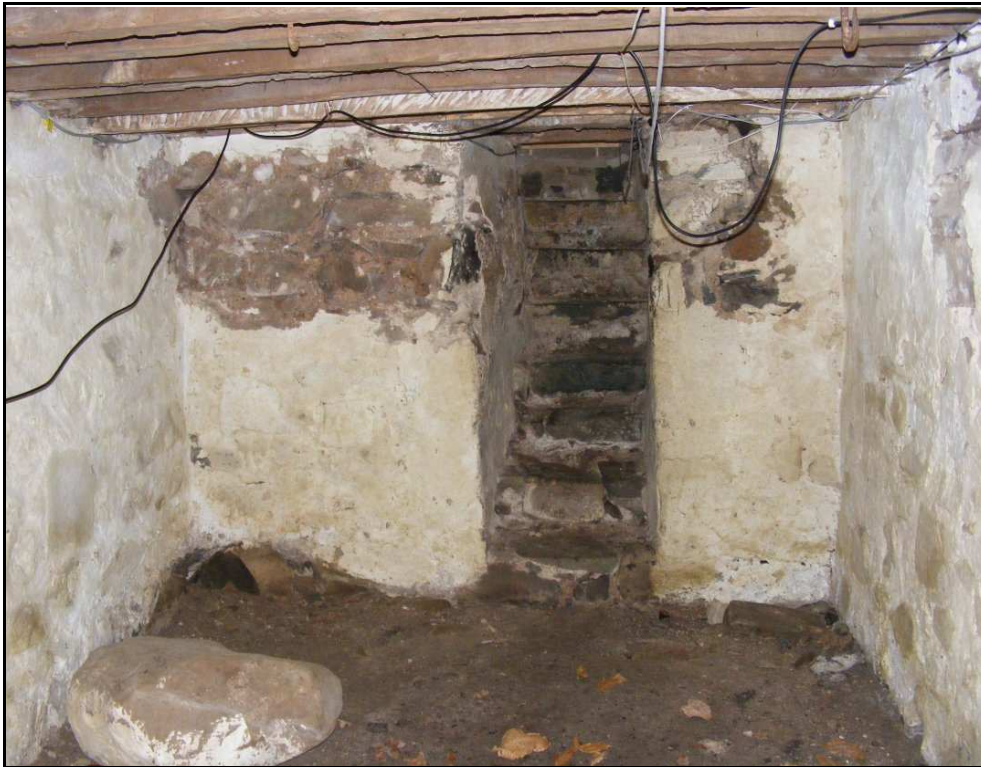
**Figure 4**, The steps down from the tower (T) into the basement (B). Notice the curve of the steps.

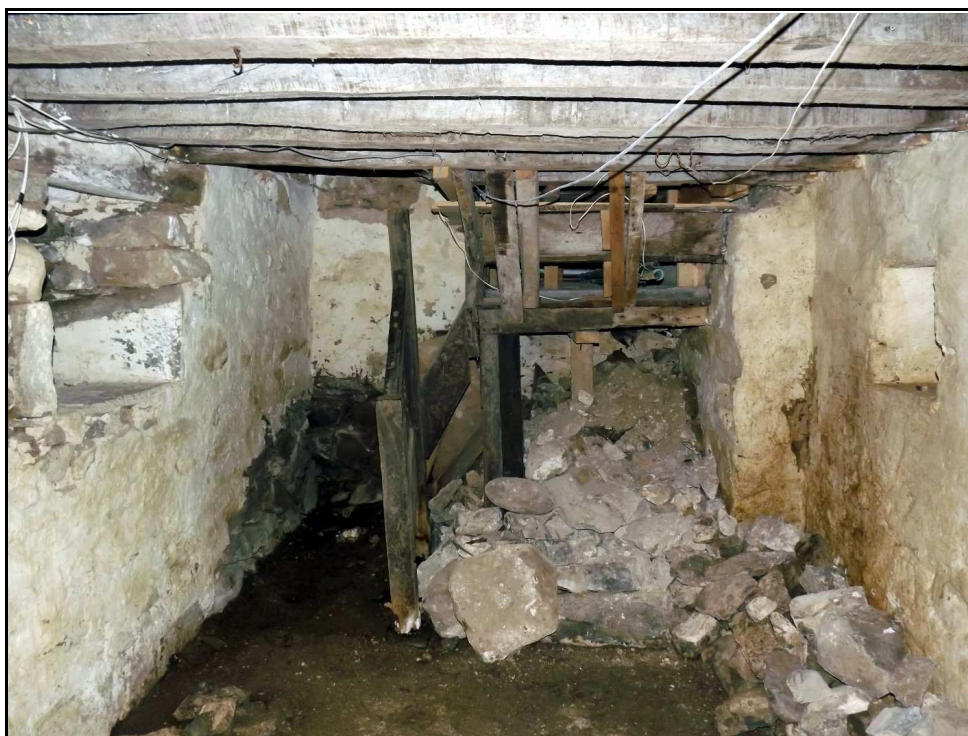
**Figure 5**, The eastern portion of the basement (B) with the remains of the old wooden stairs. Notice the wall thickening to the right of the stairs. The beams of the 1970's floor make up the current ceiling of the cellar.

The eastern basement also differs from the western one in having an eighteen inch thickening in the south-east corner of the chamber (Fig.5). Why the crosswall is thickened here cannot currently be fathomed. It is possible that this is connected with the ruined wooden staircase that comes down from the floor above at this point. This appears to have been reset at some point and could just be the shaky stairs referred to in August 1874 when (Edward) Tracy Turnerelli<sup>\*3</sup> recorded his visit to the cellar, although the current stairs down to the cellar from the tower (T) seem more likely from the description.

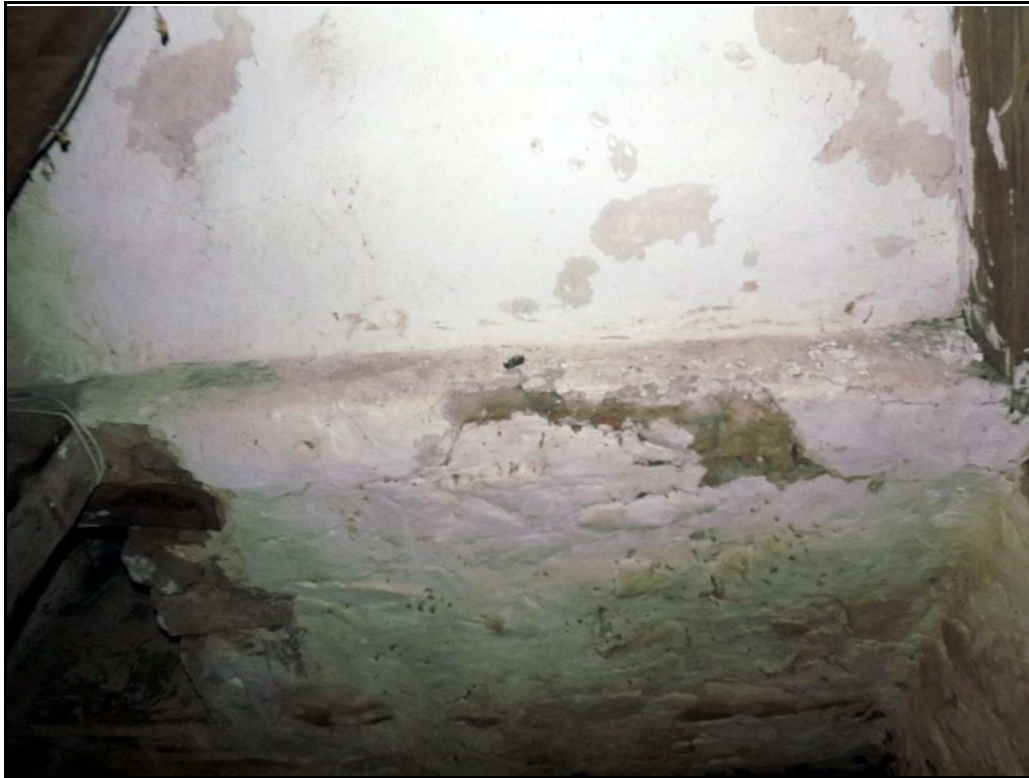
**Figure 7**, The floor offset in the basement (B) seen from the ground floor level of the house in the old stair well.

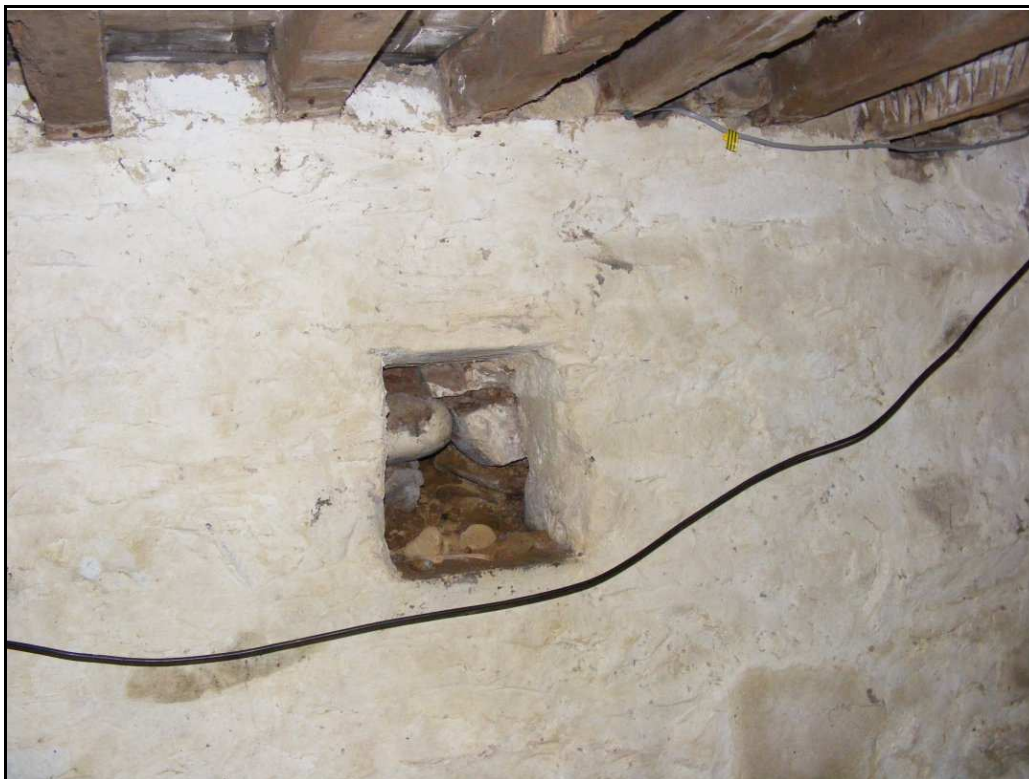
**Figure 8**, The westernmost niche in the cellar wall in the basement (B) showing the rubble filled packing in the adjacent chamber.

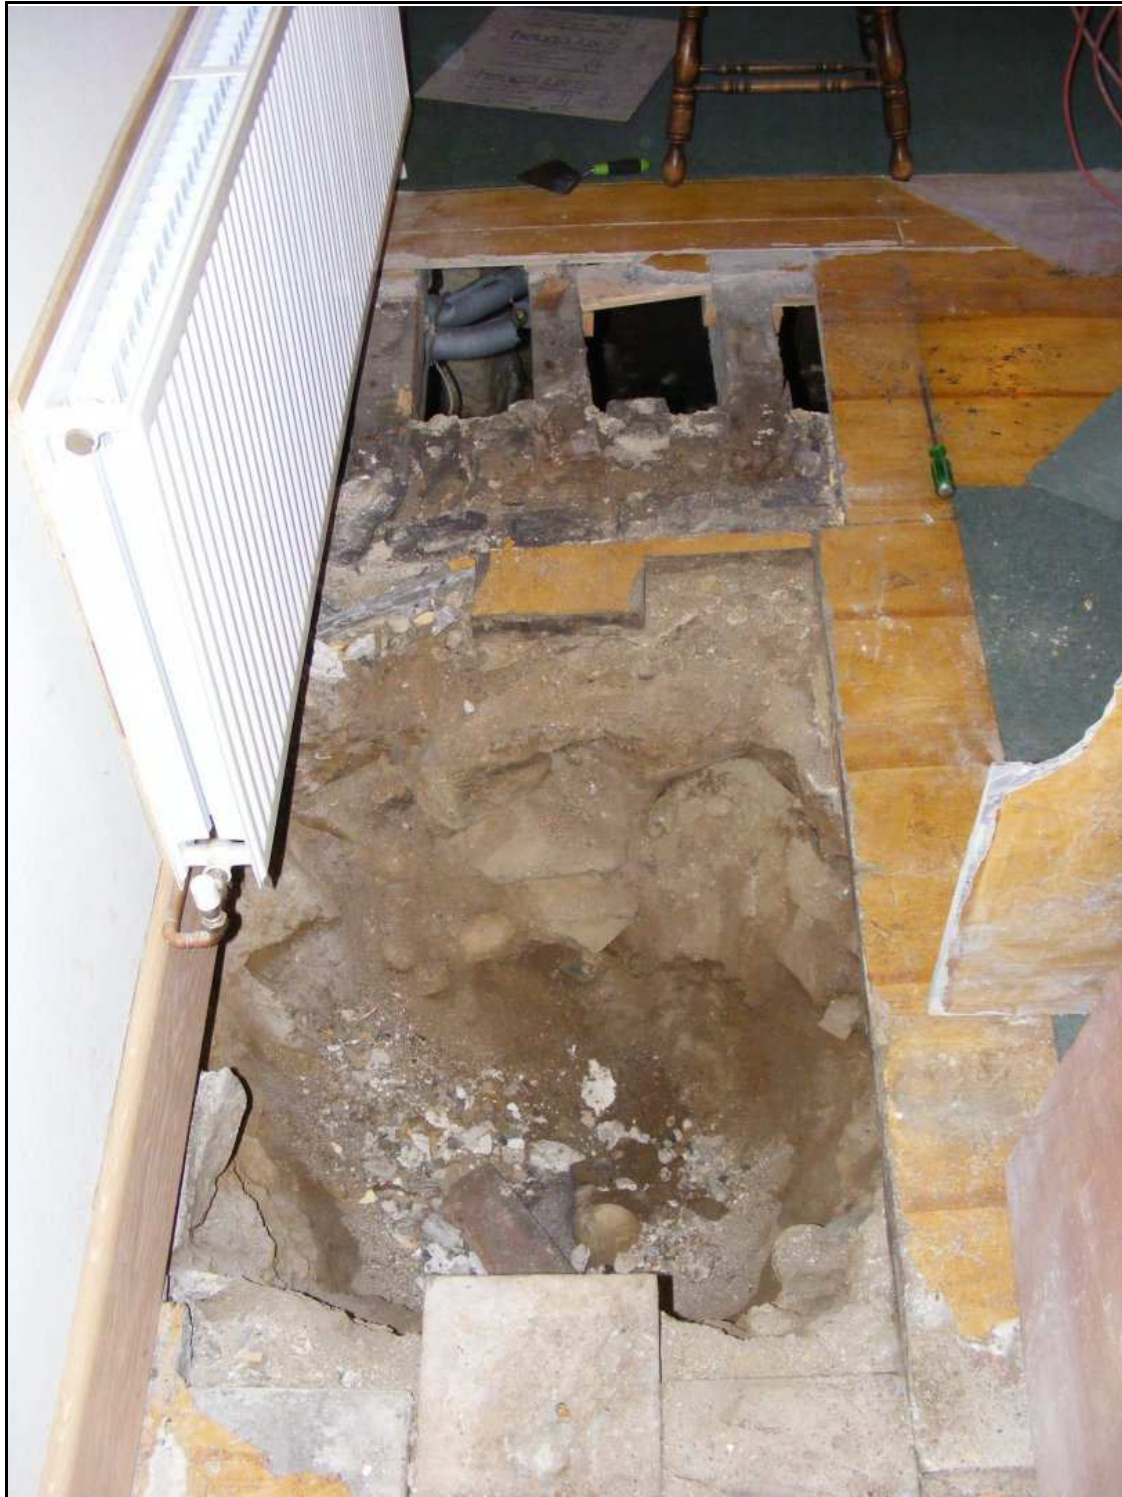
**Figure 9**, The shallow excavation into the rubble fill in the south-western portion of the basement (B) from the southern range (S) door. The retaining wall and the north-western cellar can be seen under the joists in the background.

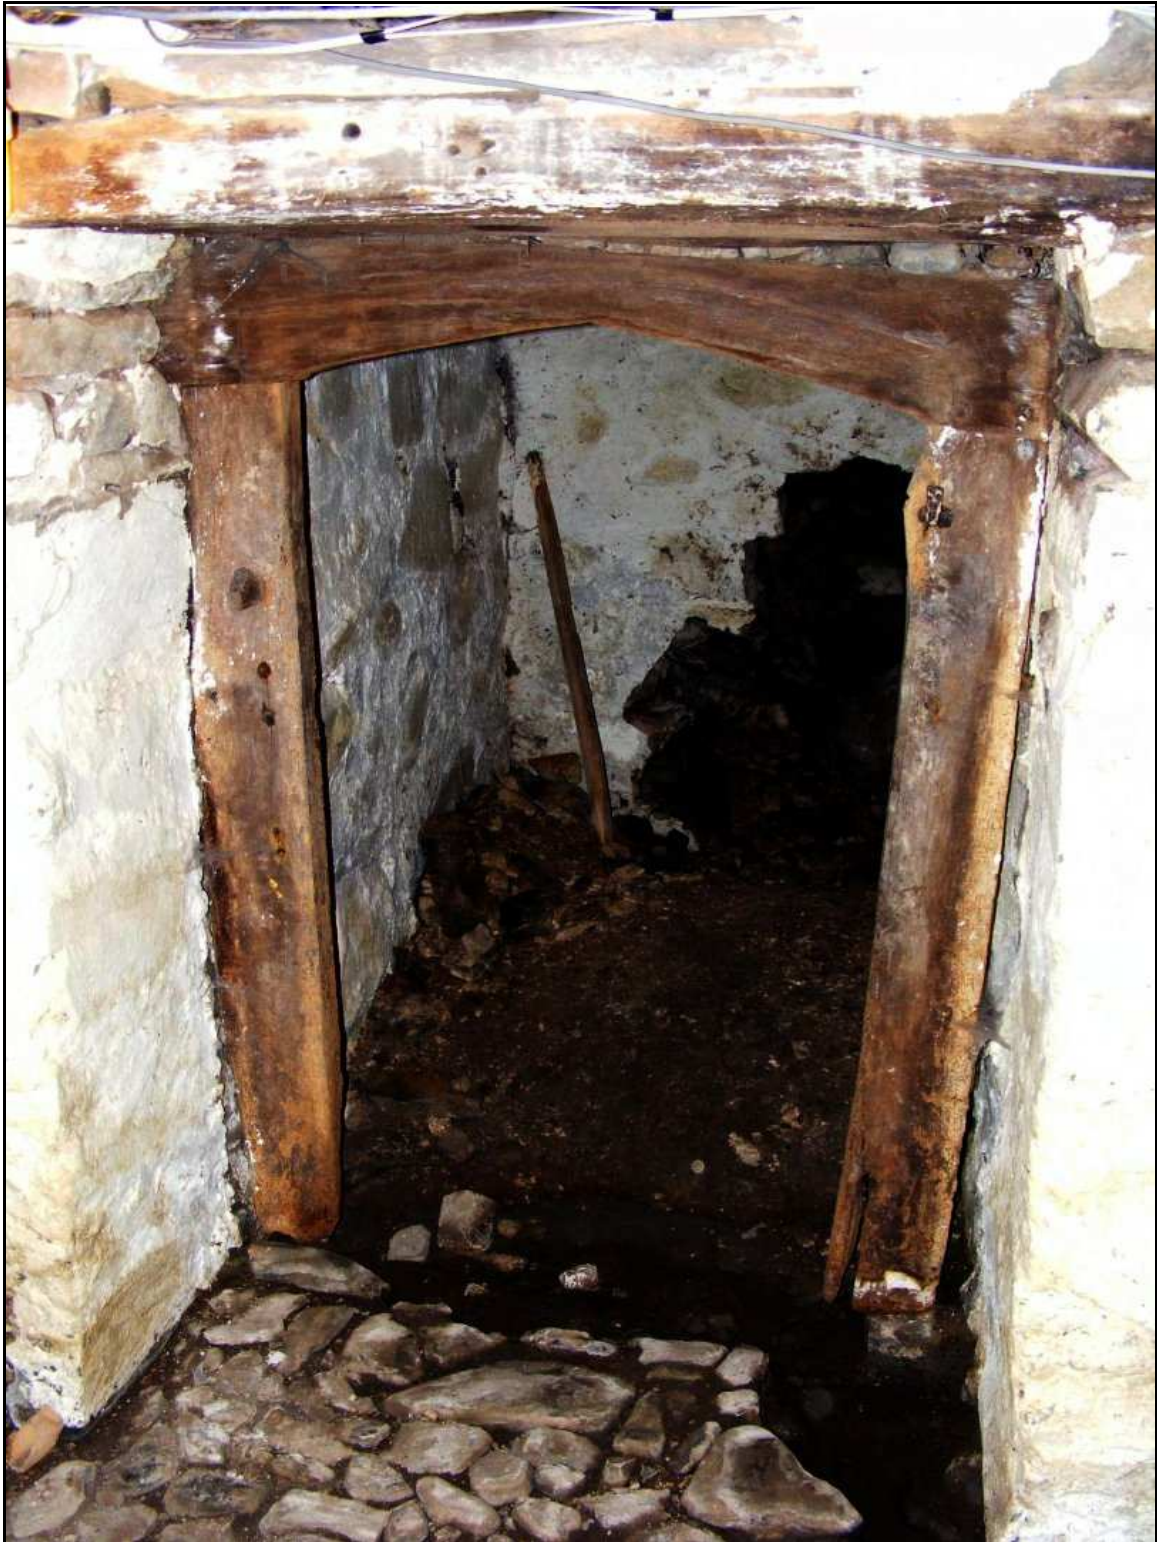
**Figure 10**, The doorway from the basement (B) into the basement of the porch (P). This has a sixteenth century 'feel' to it, the arched header, if not the jambs could be this old. Note the angle of the right hand jamb and the two hinge pivots, the lower one missing. No door could have hung here with the jamb at its current angle. Most likely the whole thing was reset in the 1970's when the floor above was laid.

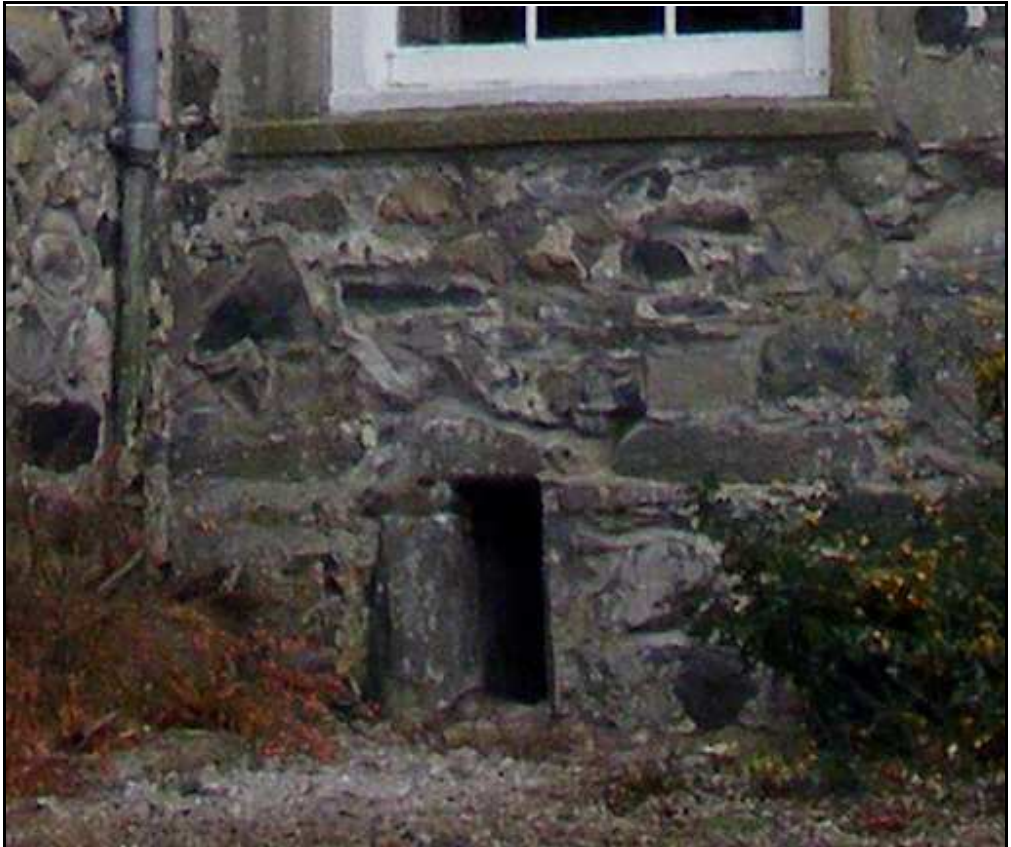
**Figure 11,** The western window embrasure in the basement (B).

(Fig.11). Both these features might be original. Externally the window is made up of only four quoins making a roughly rectangular light (Fig.12). This is probably a sixteenth century reconstruction as can be judged from its rough and ready style. Internally the aperture is capped by a wooden lintel which again tells against the current sides of the structure having any great age.

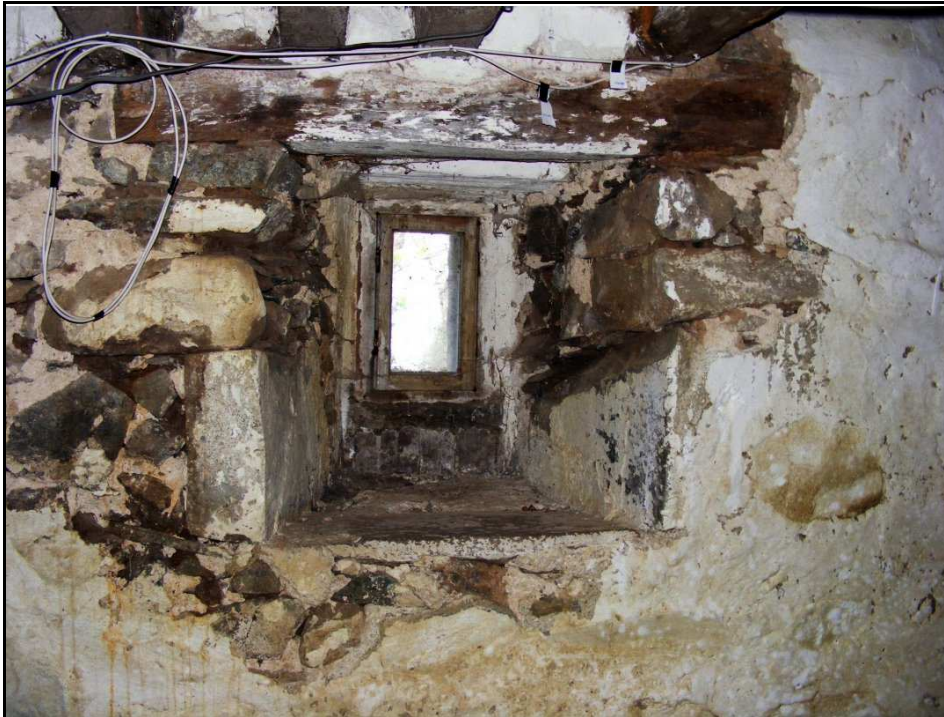
**Figure 12,** The western basement (B) window.

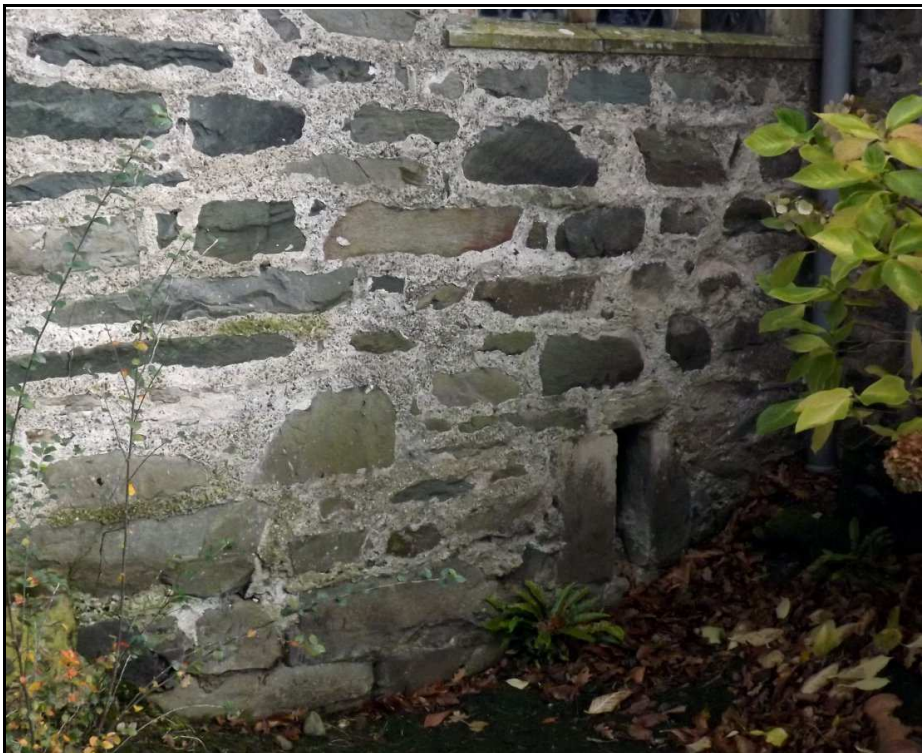
**Figure 13**, The remains of the embrasure of the eastern basement (B) window. Notice the two lower quoins and base of the structure and more modern lintel above. Notice the break line between builds running above the two side quoins.

The eastern window is not an exact twin of its western counterpart. Indeed its design would suggest that much more remained of this light when it was rebuilt. The aperture has another thin stone base and two quoins on either side making up the base of the aperture. These could well be original medieval work (Fig.13). Above the two quoins the aperture has obviously been rebuilt and the walling is capped again by a wooden lintel which seems more nineteenth century than sixteenth. Externally the light is similar to the western one, being made up of four weathered, but originally well cut pieces of freestone which again show obvious signs of reuse. However, externally the wall at the lower level of the light can be seen to consist of large sandstone boulders (Fig.14). These are not seen elsewhere at the site and would appear to relate to an early build. Sandstone boulders are also found in the build of the chancel of Penmon priory (Fig.15).

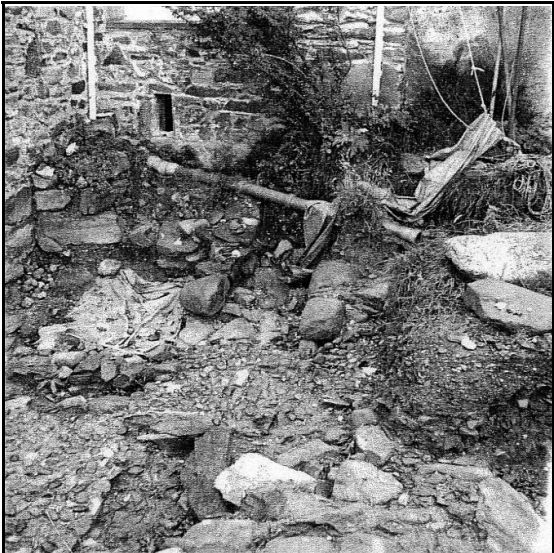
**Figure 16**, The 1993 excavation north of the east basement window showing the sandstone blocks to the left by the pipe.

excavators (Fig.16). Unfortunately the wall facing around the western window was not exposed at all (Fig.17).

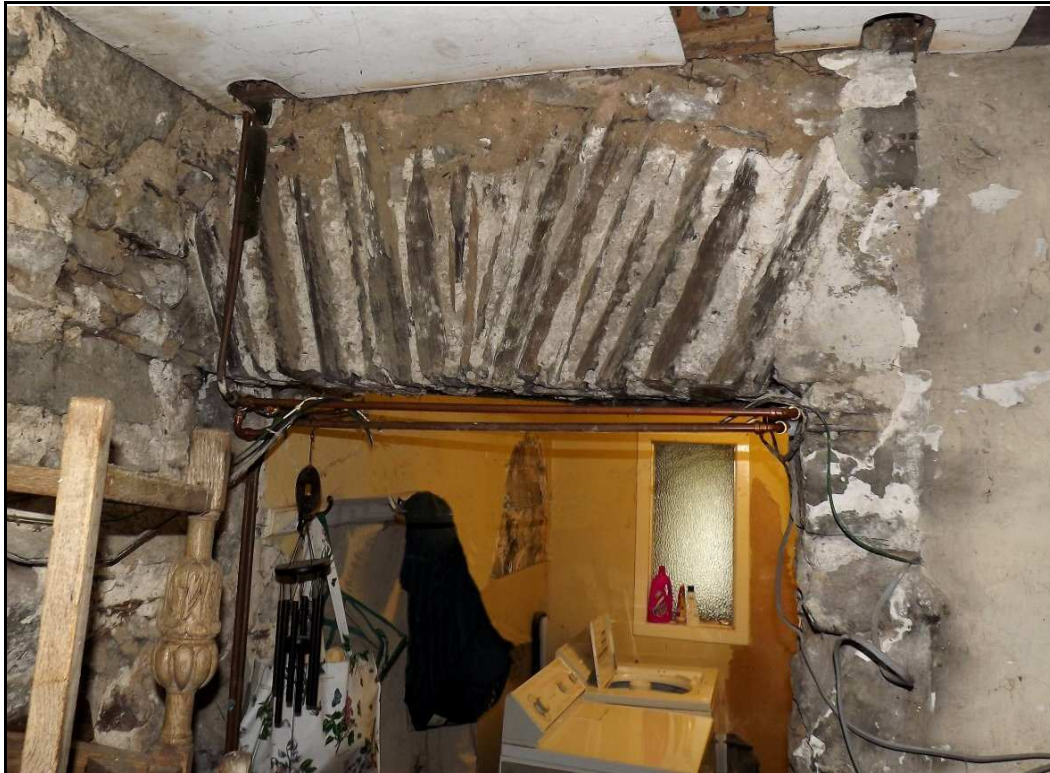
**Figure 19**, The voussoir in the external south wall of the east range (E) from the tool shed. Notice how it penetrates the wall of the house (H) to the upper left.

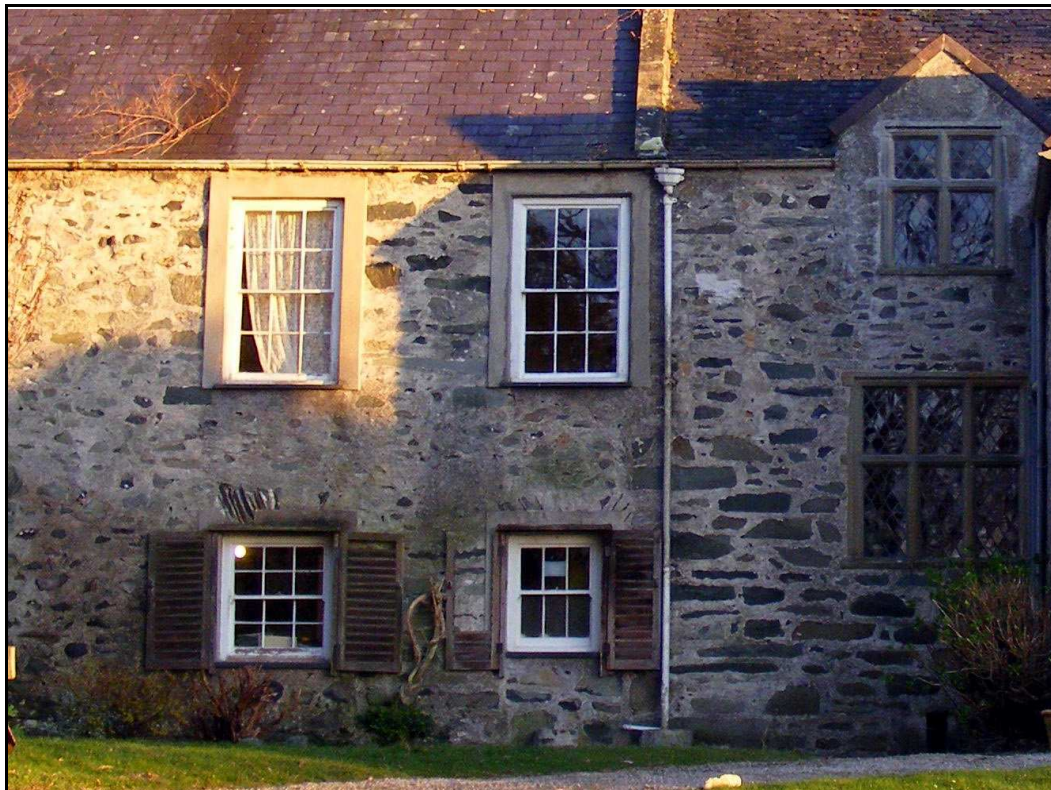
**Figure 20**, The east range (E) to the left, divided from the house (H) to the right between the drain pipe and the central windows. Notice the two ground floor voussoirs.

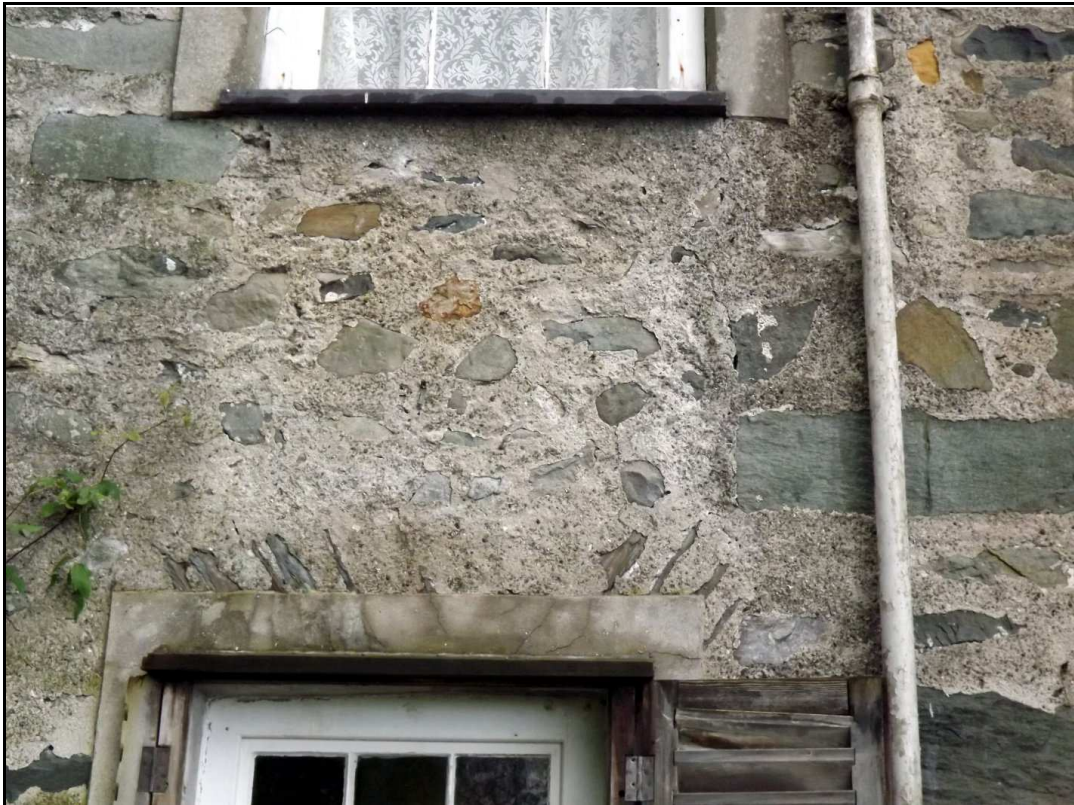
**Figure 21**, The clear junction between the irregular rubble of the east range (E) to the left, and the more coursed masonry of the house (H) to the right, occurring between the drainpipe and the window edges.

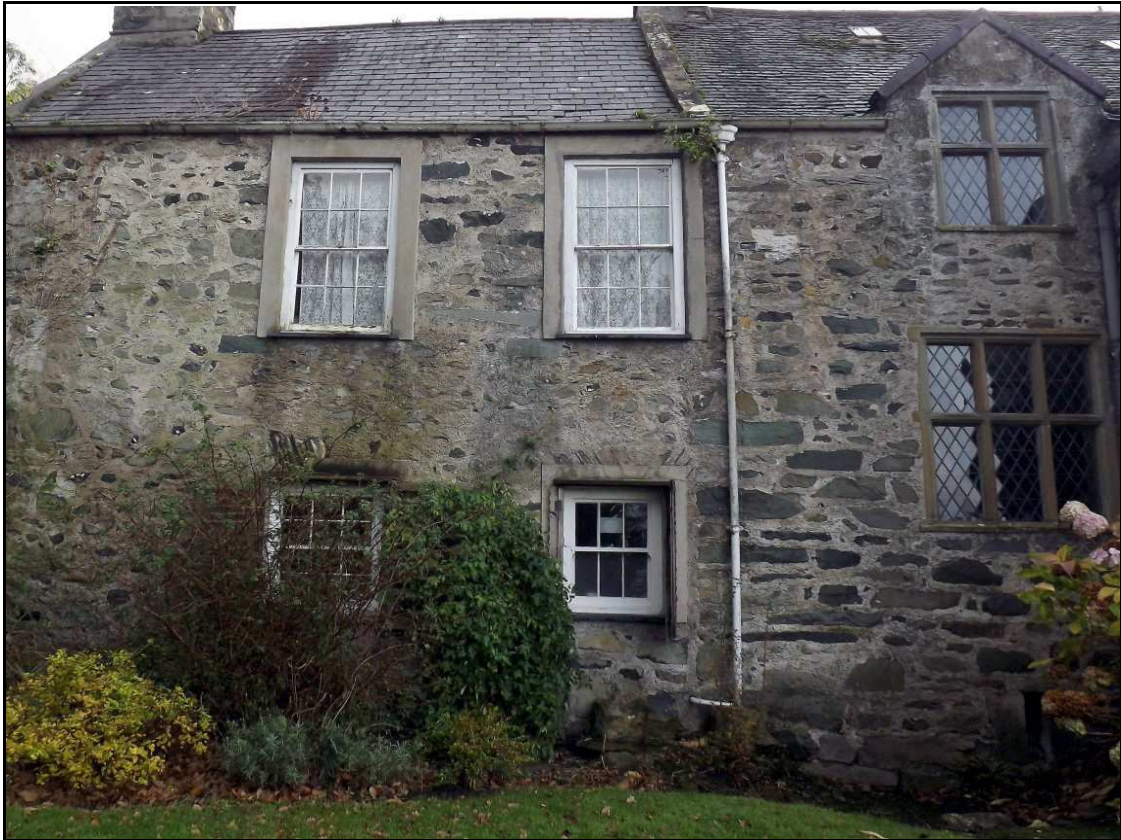
**Figure 23**, The converted doorway in the centre still showing the different masonry style at the base where the door has been blocked in.

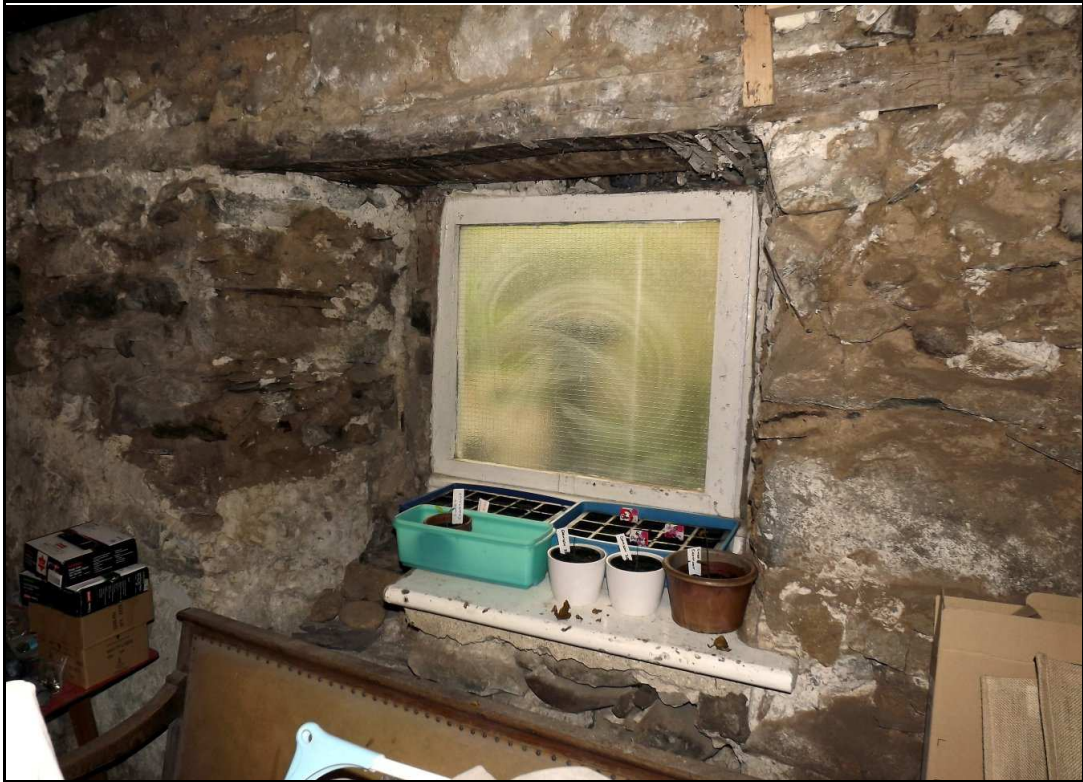
**Figure 26,** The south-eastern window embrasure in the east range (E). The current sill quite clearly lies upon a later infilling of the original splay.

On the opposite wall of the range (E) the southern window aperture is similar to the northern one, although greater damage to the surrounding plaster work shows clearly that the wooden lintel overlies a medieval design opening (Fig.26). This line of rebuilding is reminiscent of that already looked at in the basement (B). It is also clear that the base of the embrasure has been packed with rubble to make a flat surface for the current sill. The original aperture was deeply splayed at the base, and probably also at the top, although this area has been relaid. Externally, where the current ground level is at least four feet higher than the interior, this window also has a slate voussoir (Fig.27). The aperture, which is filled with a wooden nineteenth century style window, does not have concrete surrounds like the other two modern windows in the north wall. The mortar around the window base has much shell-filled material in its make up, unlike that found in the rest of the wall which consists of a red-brown mortar containing little lime. Quite possibly this window was not replaced at the same time as the windows to the north as this was on the sheltered side. This might also explain the lack of a concrete surround around the window. Internally the sides of the window aperture would appear to be original masonry on which the rest of the east range is supported. This suggestion is strengthened by the mortar in the wall running up to the full height of the building consisting of a red clayey material which now has little lime left in it. This could possibly be the oldest mortar remaining on site, although it should always be remembered that walls are always prone to be remortared and the red-brown mortar could simply be an isolated survival. It should also be noted that stone walls tend to decay quickly if the mortar is not of a good quality or is not regularly replaced. The collapsed remnants of Prysor (Fig.28) or Carndochan (Fig.29) castles are a good reminder of this, as too are the remains of the Bishop's Palace at Gogarth (Fig.30)

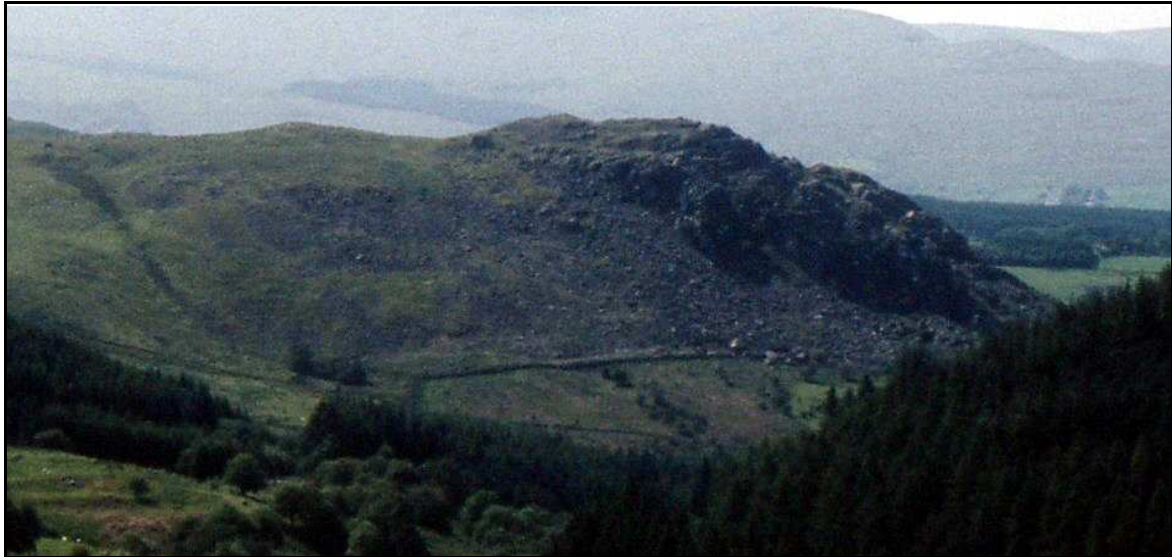
**Figure 29**, Castell Carndochan from the east. Again see what remains of the castle stone strewn over the hillside after a catastrophic failure of the walls once the mortar rotted away.

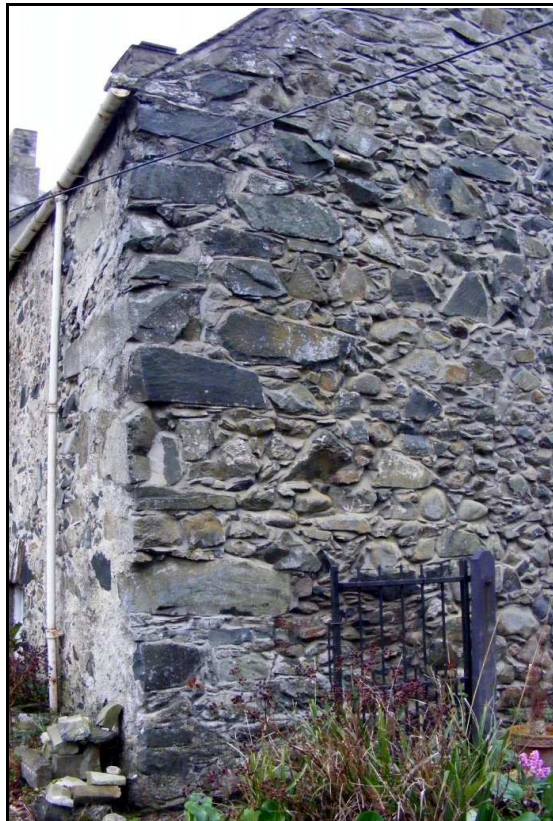
**Figure 31**, The southern face of the eastern range. Notice how the highly irregular east end of the wall contains many large blocks totally absent in the rest of the wall.

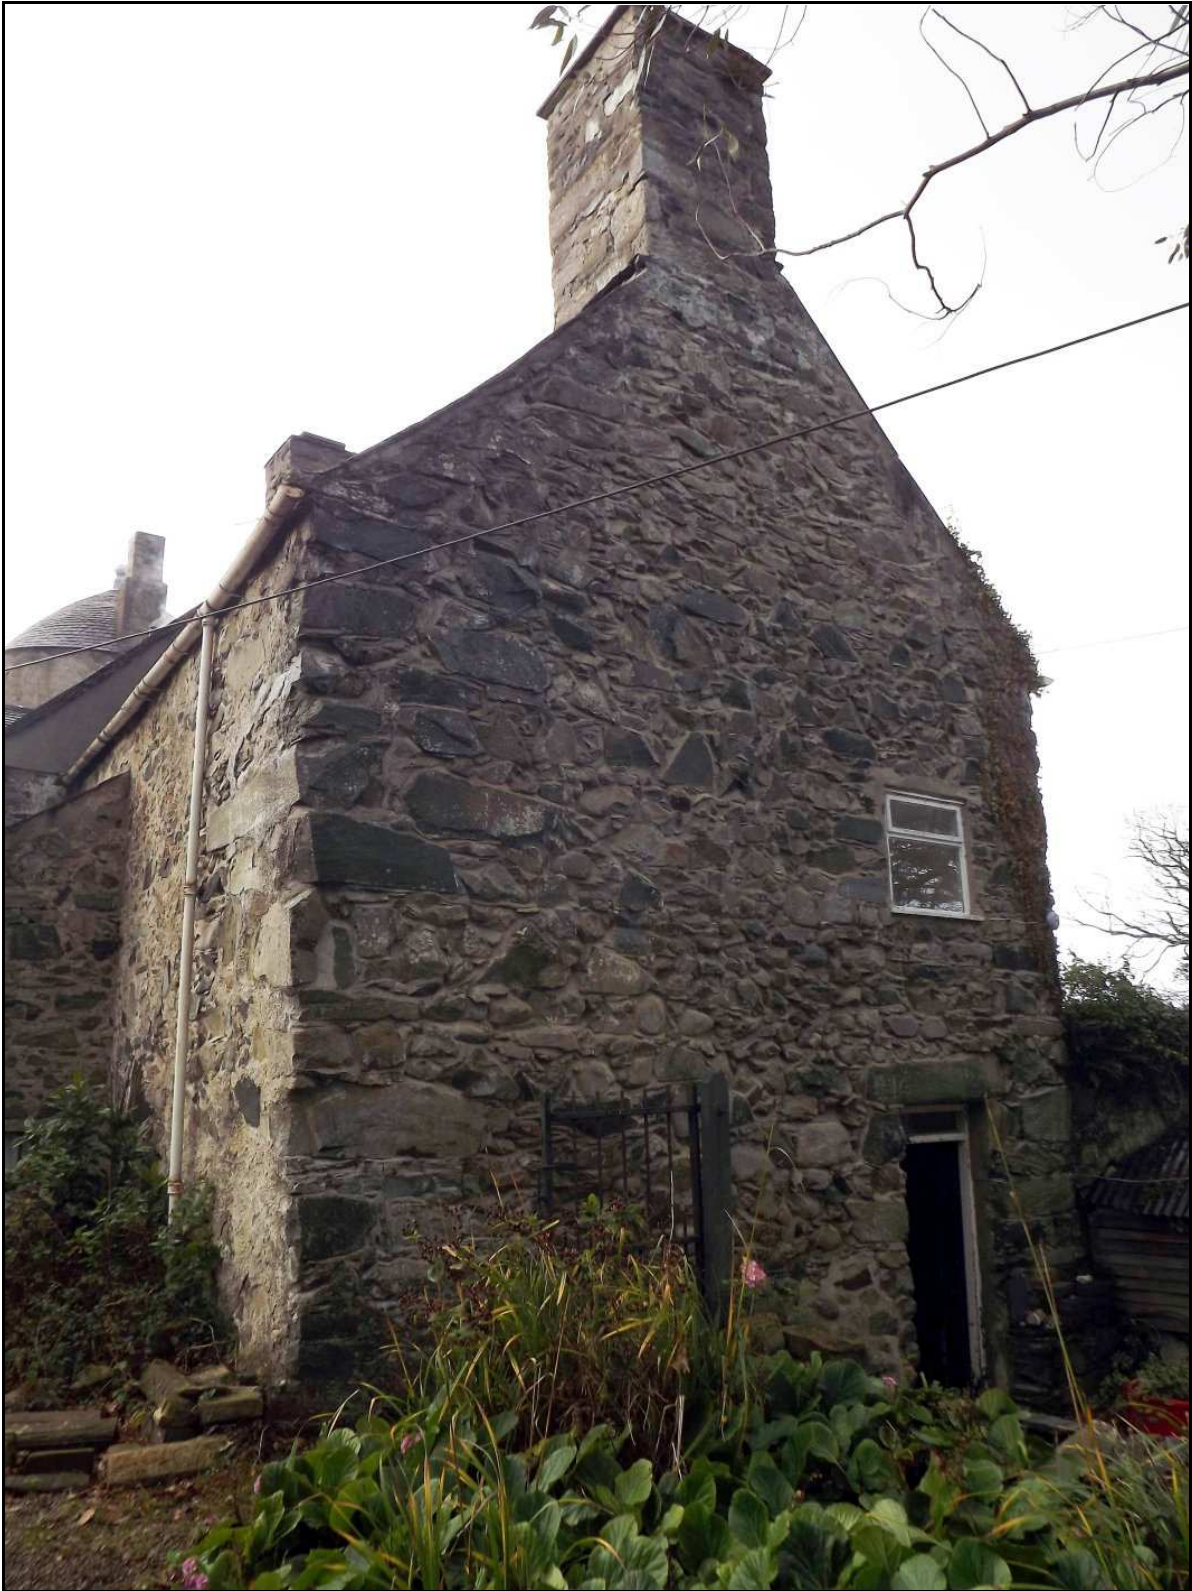
**Figure 32**, The southern corner of the east wall of the eastern range (E). Notice the large quoin stones and the different masonry style of the east wall.

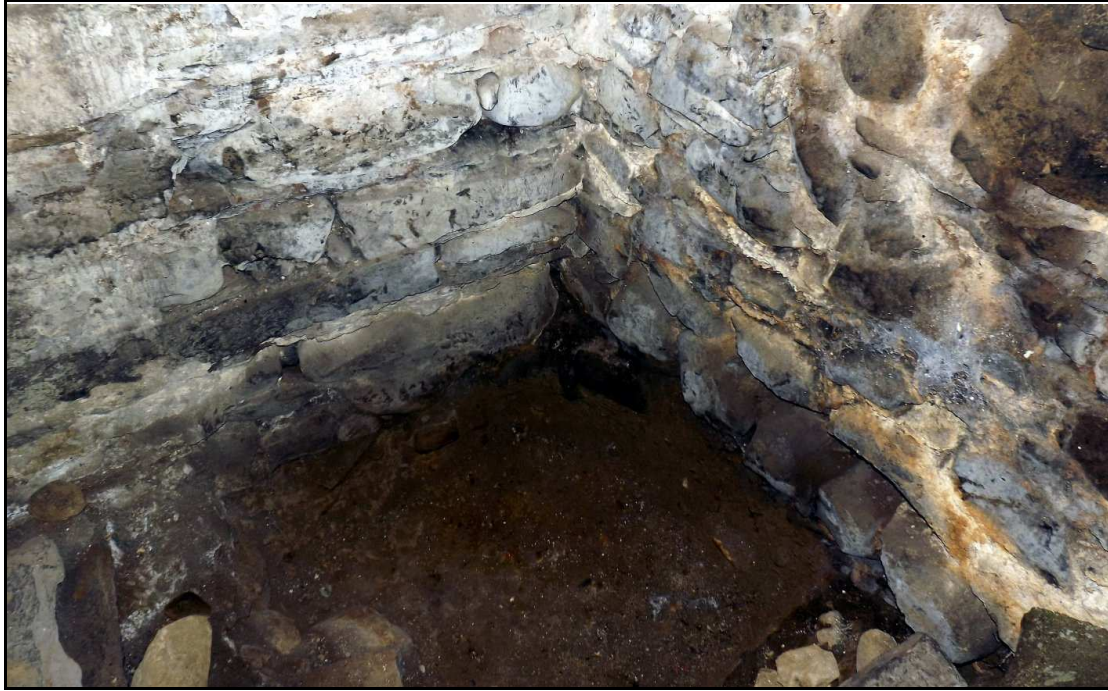
**Figure 34**, The north-east corner of the fireplace showing the replacement east wall of the east range (E) resting on a row of water washed sandstone boulders to the bottom right. The chimney north wall to the left can be seen to make butt joint with the older east wall.

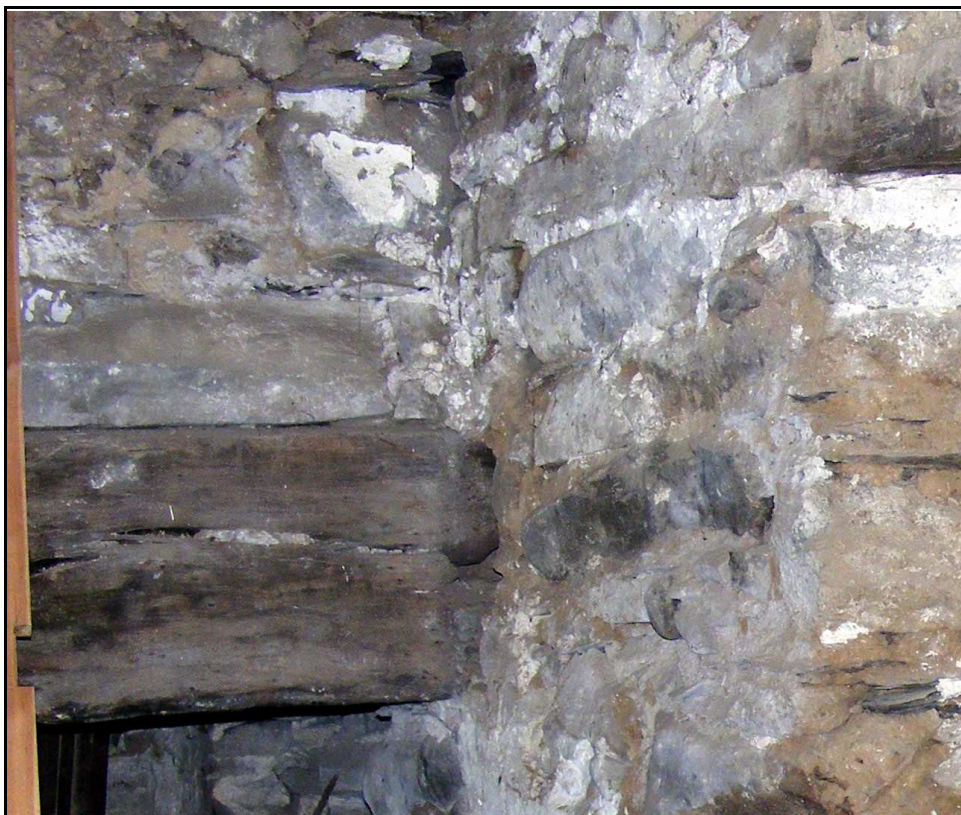
**Figure 35**, The lintel of the fireplace (bottom left) with chimney wall above, hacked into the older south wall of the east range (E) to the right.

Internally the fireplace in the south-east corner of the east range (E) would appear to be a tertiary feature. This can be seen as the wooden top of the fireplace has been hacked into the older south wall of the building (Fig.35). Similarly the north-eastern wall of the fireplace forms a butt joint against the second or third phase east wall of the range (Fig.34). Higher up the wall the rebuilding work can be seen to occur in the roof level, with the much decayed south wall of the structure still retaining the reddy-brown clayey mortar as noticed in the ground floor of the building.

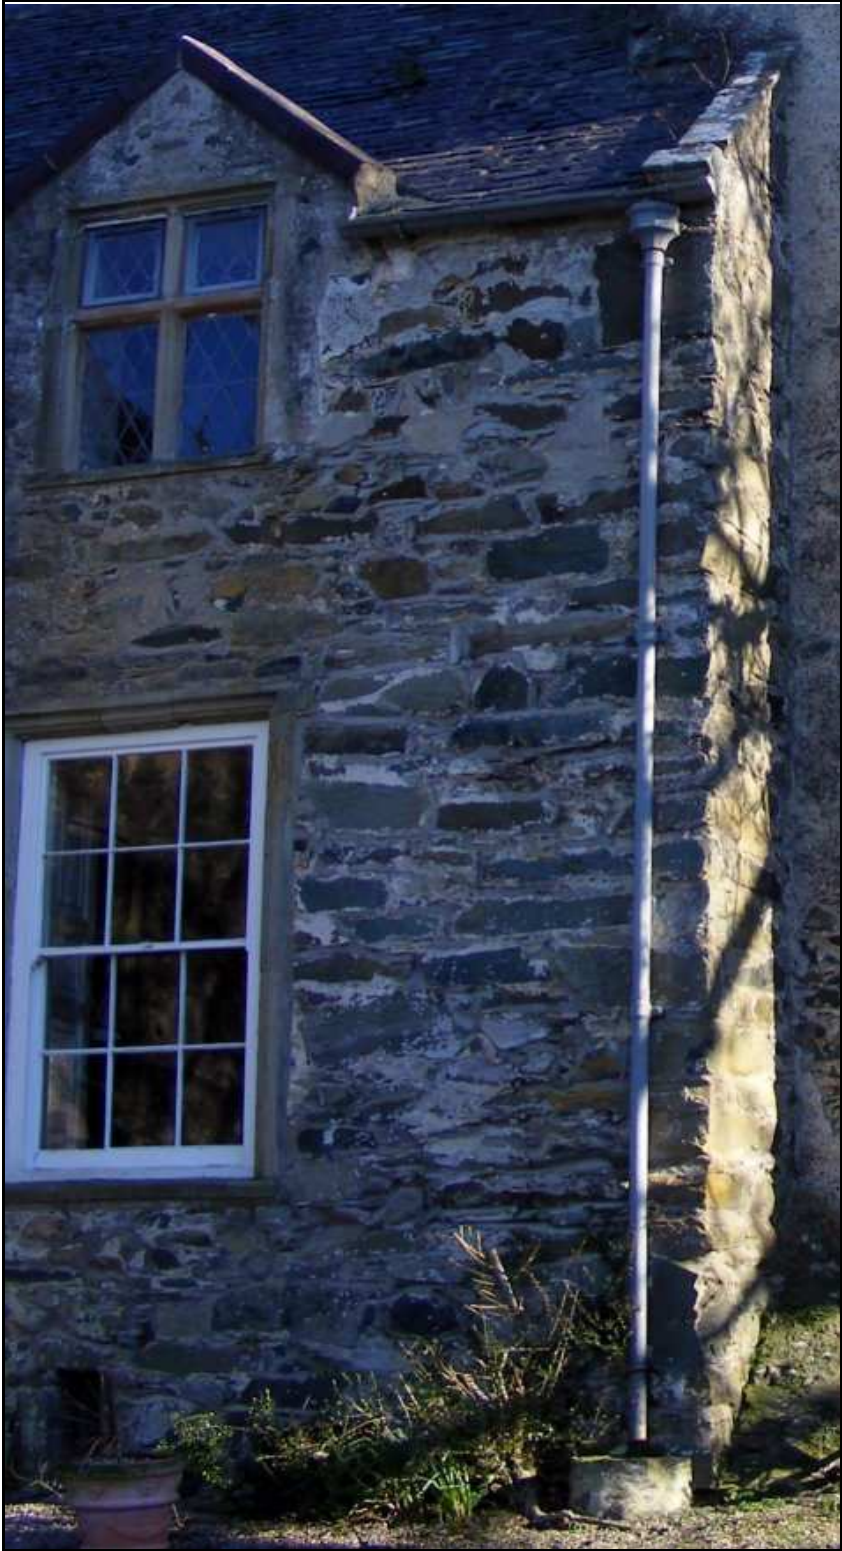
**Figure 37**, The north-western corner of the house (H), showing its regular build and few quoins.

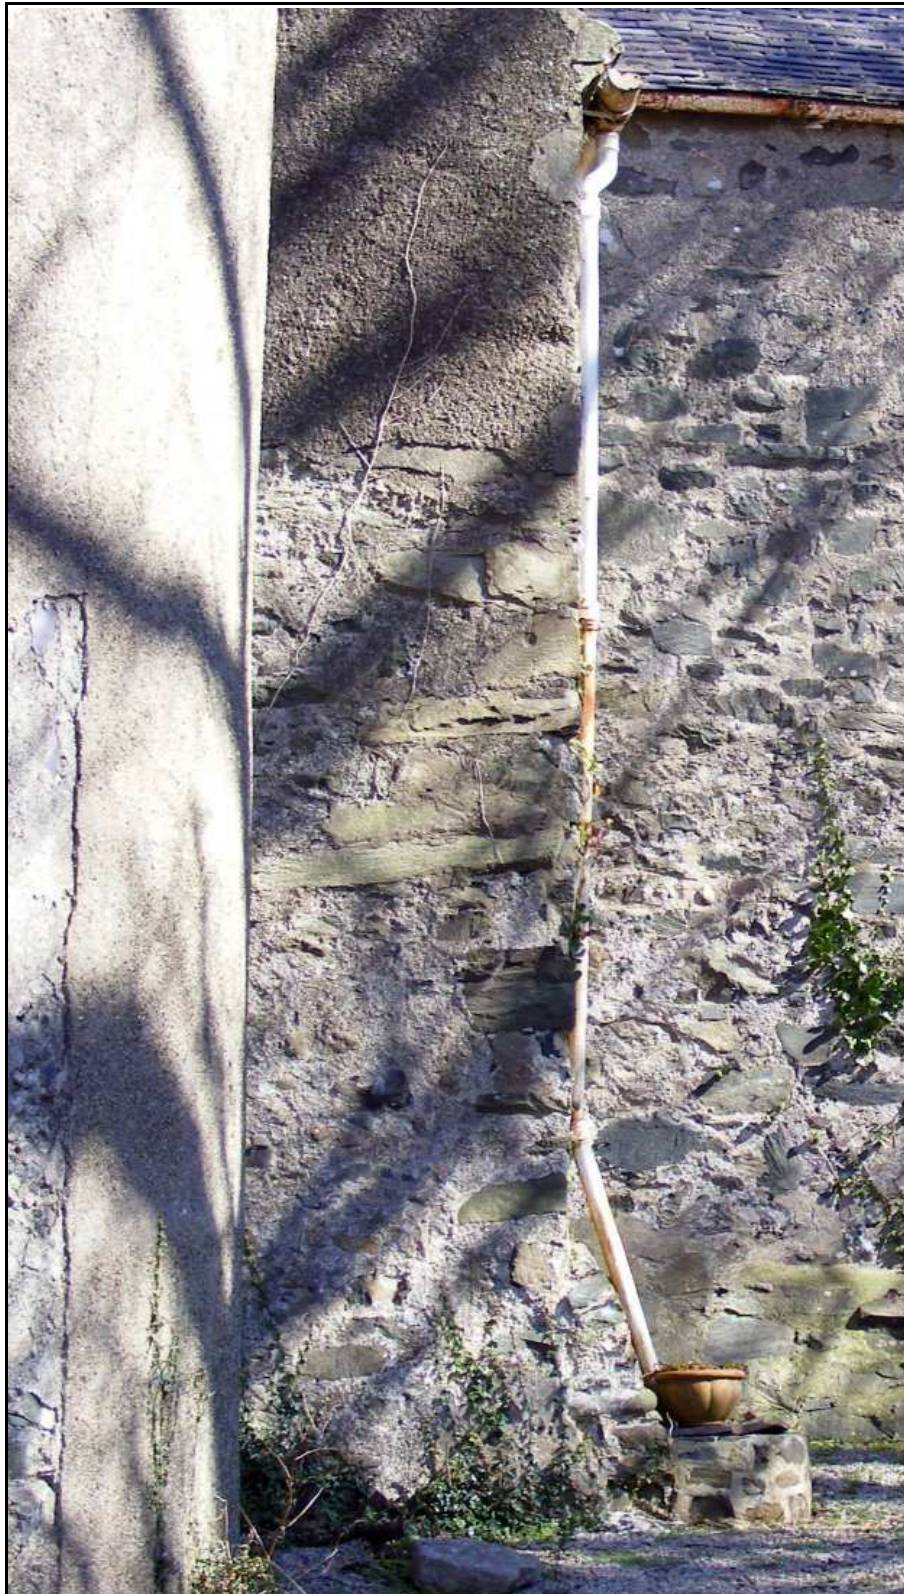
**Figure 38**, The south-western corner of the house (H) where an apparent doorway has been walled up. Notice the later still sloping plinth under the downpipe next to the drain. The tower (T) is to the left and the south range (S) to the right. The lintel of the blocked doorway is the green schist-like stone that stretches right across the wall.
